2019 Eight Point Lake Water Quality Report

Clare County, Michigan

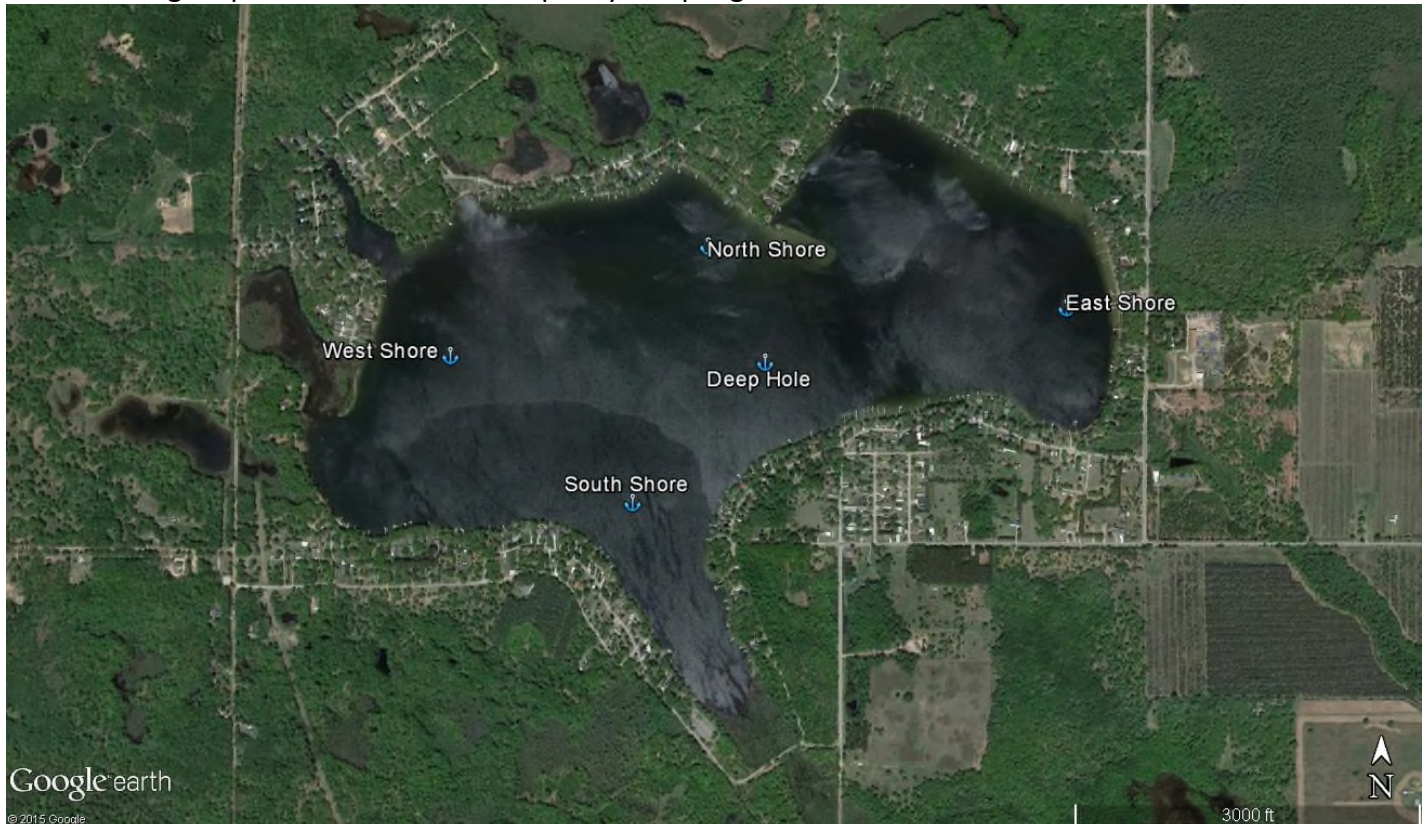
The following map shows the five water quality sampling locations.
